INSPECTION REPORT

**5505 SHADY DRIVE
FORT WORTH, TX 76135**

Concerning: _____
5505 Shady Dr, Fort Worth, TX 76135
(Address or Other Identification of Inspected Property)

By: Michael Coviello #20659 _____ 3/26/2020
(Name and License Number of Inspector:) (Date)

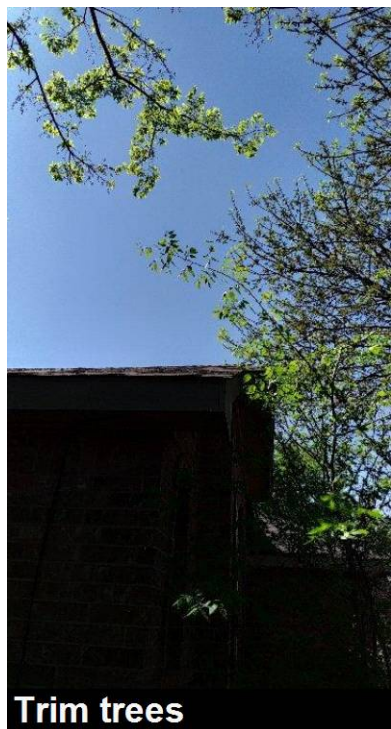
A tree on the North side was in contact with or very close to the dwelling. Trees too close to a structure can cause significant damage during high winds or as the tree grows. We recommend removal or significant trimming of the tree, which may help to prevent future damage to the residence.

Trim trees

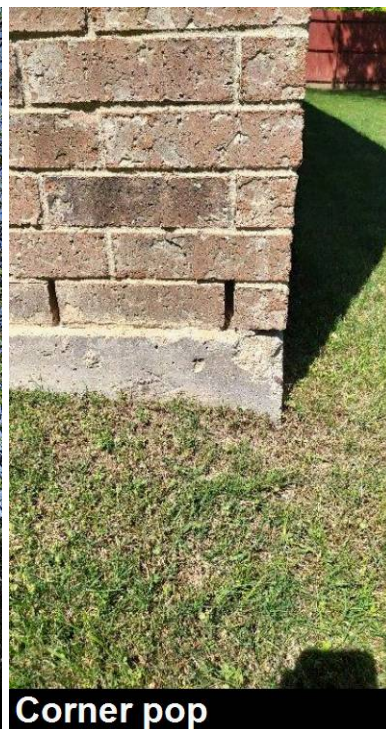
Wedge cracks or corner pops were noted at some of the foundation corners. The large majority of slab-on-ground foundations will eventually develop "corner pops" or wedge cracks. The name comes from the fact that these cracks develop at or very close to the outside corners of the foundation and frequently form a wedge at the corner. These cracks develop as a result of the expansion of the brick veneer as it is warmed by the sun. These cracks do not indicate anything unusual about the foundation. If the cracking at a corner becomes extreme, the concrete wedge may become loose and can eventually fall off. In the most extreme case, the wedge will no longer support the brick; if this were to occur, the corner should be repaired.

Corner pop

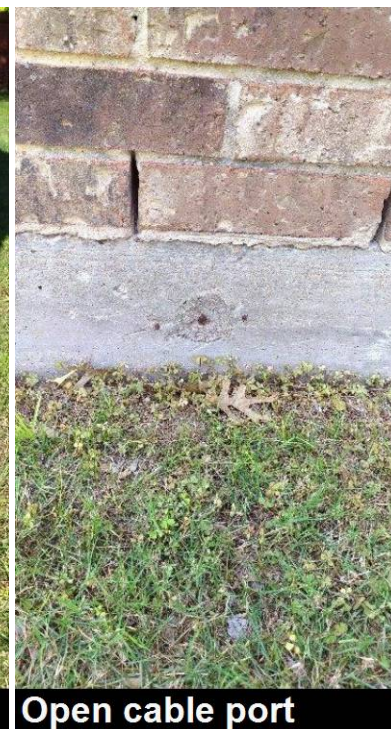
Open cable tensioning ports were noted at the East side(s). We recommend proper cleaning and sealing of any open ports to protect the cable ends from moisture and corrosion.

Open cable port

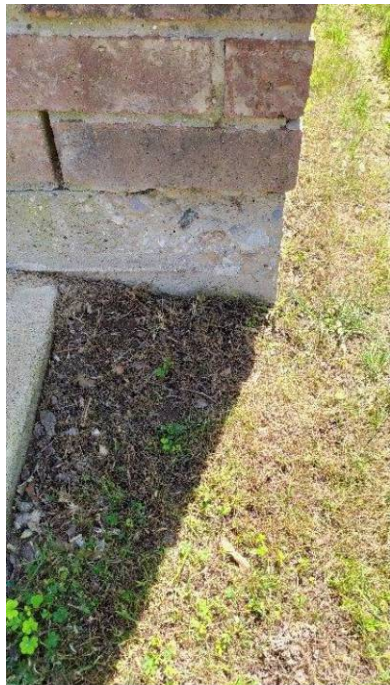
Corner pop

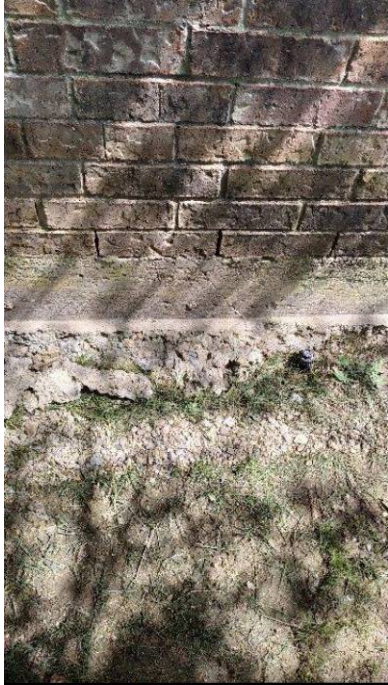
Low soil and/or soil erosion was noted near the foundation on the East and West side(s) of the structure. We recommend adding soil to these low lying areas to minimize any potential water ponding.

Add soil

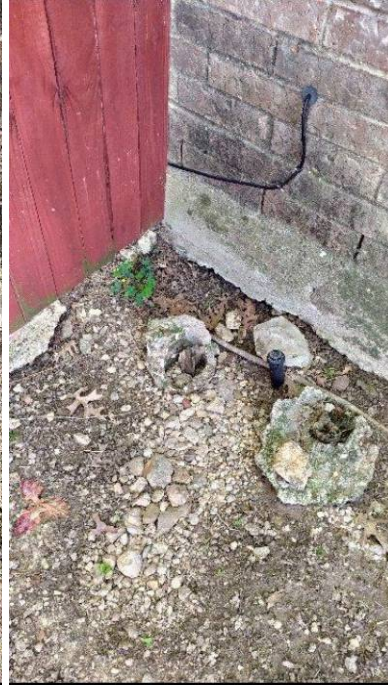
Add soil

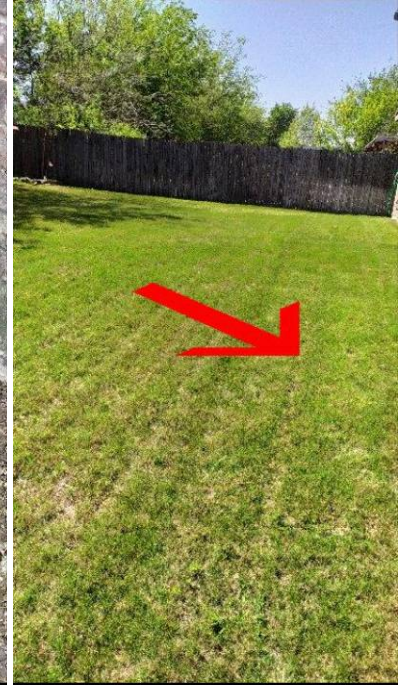
We observed a negative grading slope at the South side(s) of the structure. This will likely cause water to drain toward the foundation. Reshaping of the area around the foundation to move water away from the structure may be required. If further review is desired, evaluation by drainage specialist is recommended.

Slopes toward house

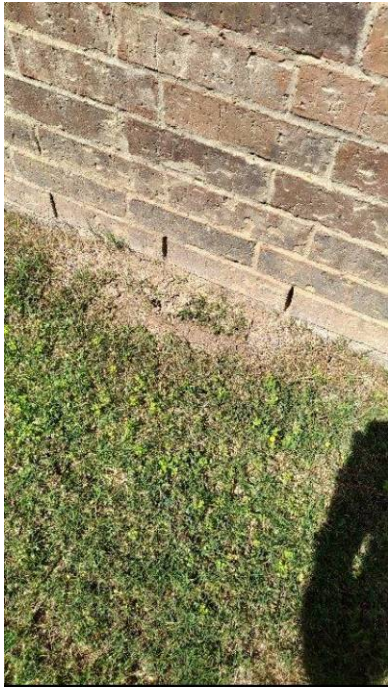
The soil line was too high at the South side(s) of the residence. With slab foundations, we advise that approximately 2-4 inches of slab show between the brick or siding and the soil. High soil lines can cause moisture retention in exterior walls, and can be conducive for a potential WDI (termite) infestation.

High soil

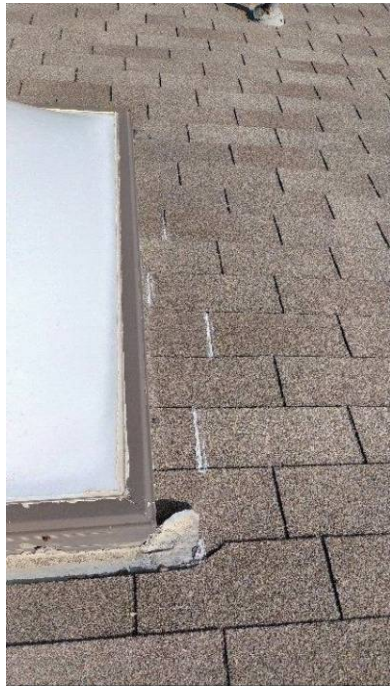
There is evidence of roof repairs where sealants were used was noted on the roof surface. When these sealants deteriorate, leaks can occur; properly installed roofing material usually does not require surface sealants. Future repairs may be required to ensure continued serviceability.

Sealant repair

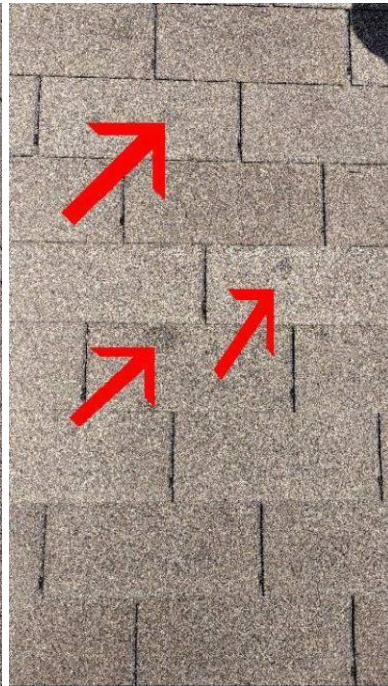
Apparent hail damage was noted on the West surface(s). We recommend an evaluation by your insurance carrier and a qualified roofing contractor to insure the roof is serviceable and insurable.

Hail damage

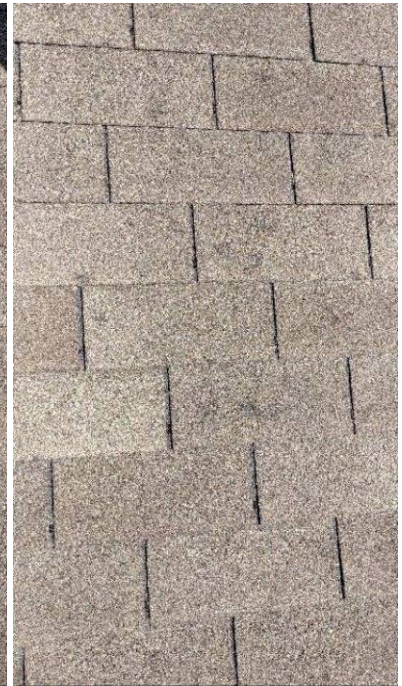
Hail damage

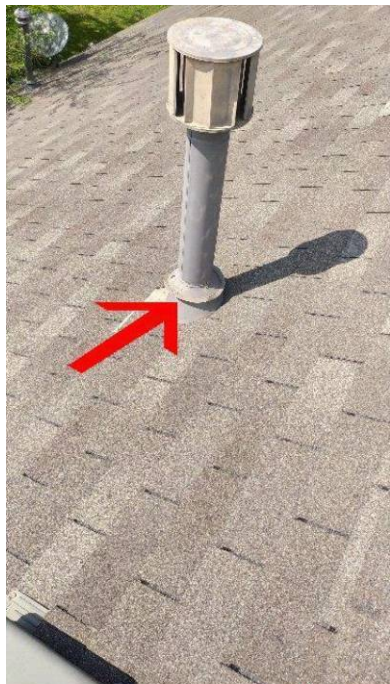
Re-seal storm collar

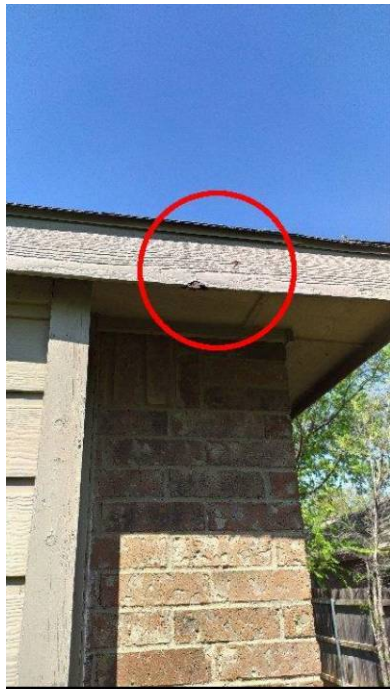
Areas of damaged fascia and/or soffit were evident. Recommend evaluation and/or repair by a qualified contractor.

Damaged soffit

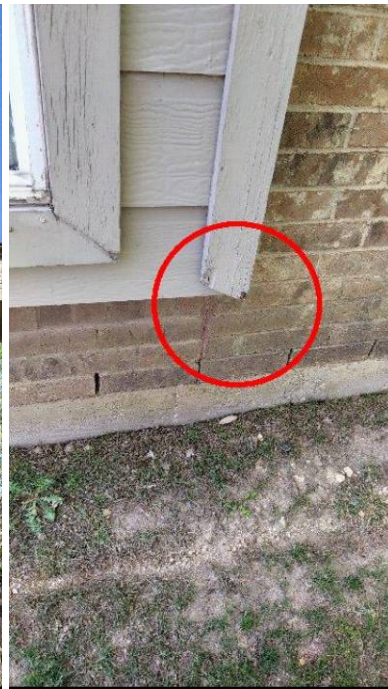
The exterior trim paint was cracked/peeling in some area(s). The regions should be scraped and painted to protect the trim from decay and deterioration. If the structure was built before 1978, lead-based paint use was fairly common. If children are going to visit/reside in the structure or you have any health concerns, you might want to consider having the paint inspected/tested by a lead paint specialist.

Trim needs paint

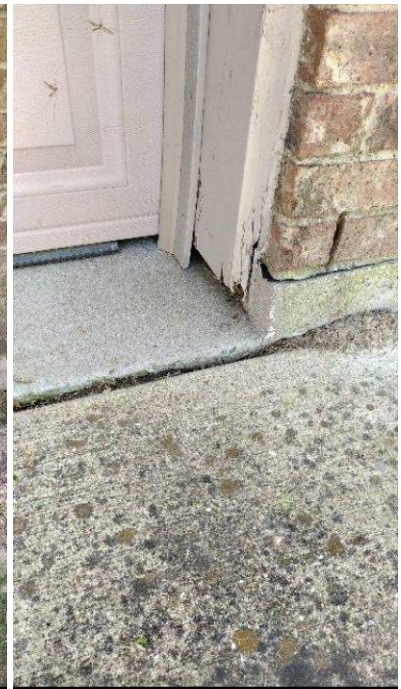
Some wood deterioration/moisture damage was noted at various locations. We recommend repairs/replacement as required, to help prevent additional damage.

Trim rot

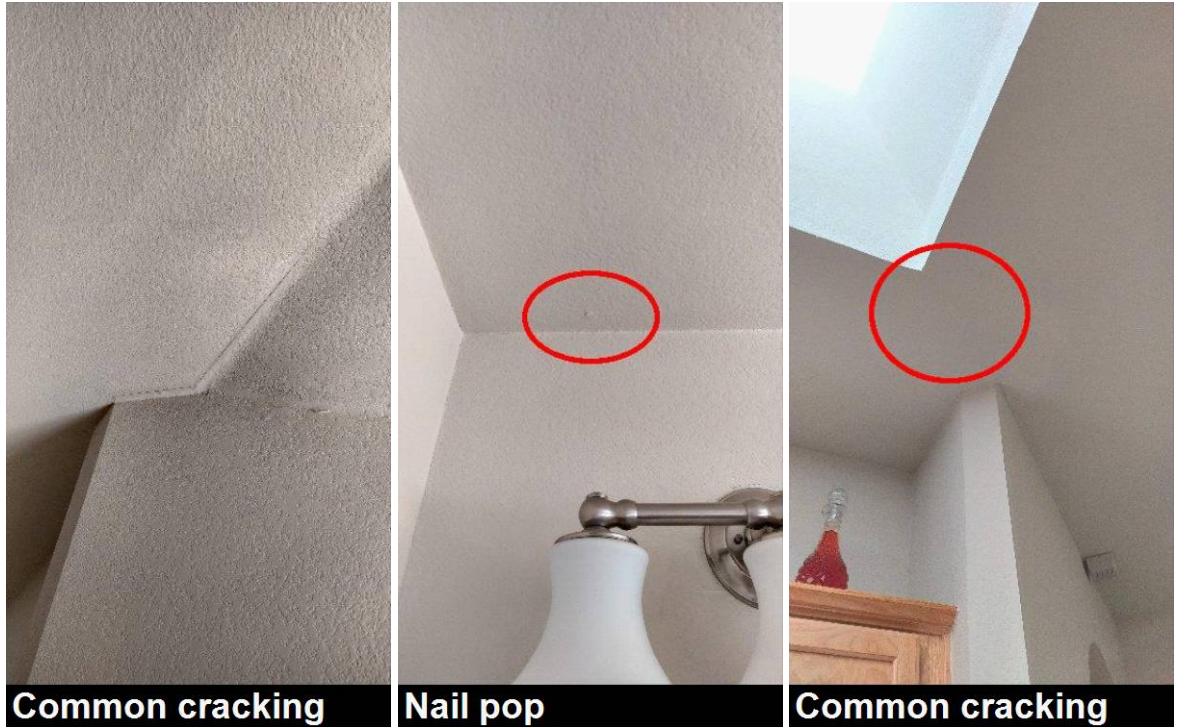
Nail pops were noted in the ceilings. They result from a variety of causes, including: normal settlement, poor ventilation or the shrinkage of the wood framing behind the drywall. Repair is usually relatively simple and inexpensive.

There were common cracked tape joints on the interior ceilings at multiple locations. This can be caused by expansion and contraction of construction materials and/or structural movement. Recommend repair as required.

Common cracking

Nail pop

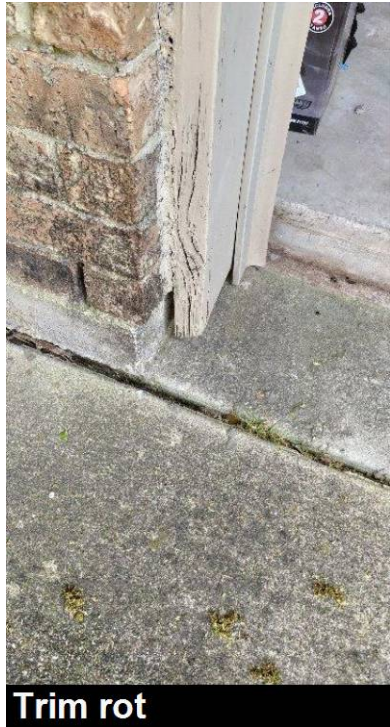
Trim rot

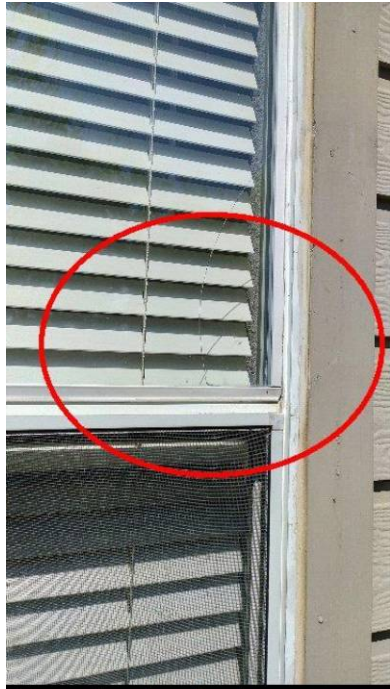
The master bedroom window was cracked.

Cracked window

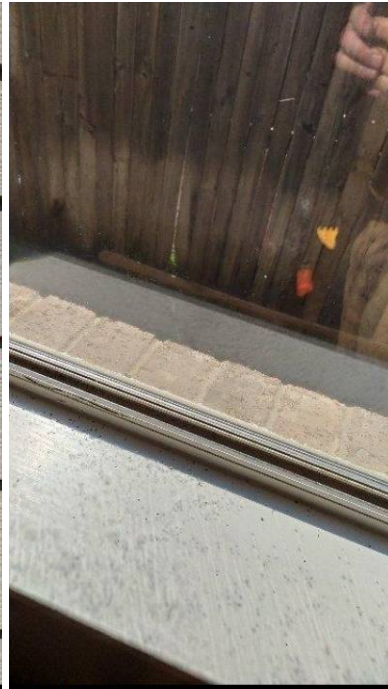
Failed seal

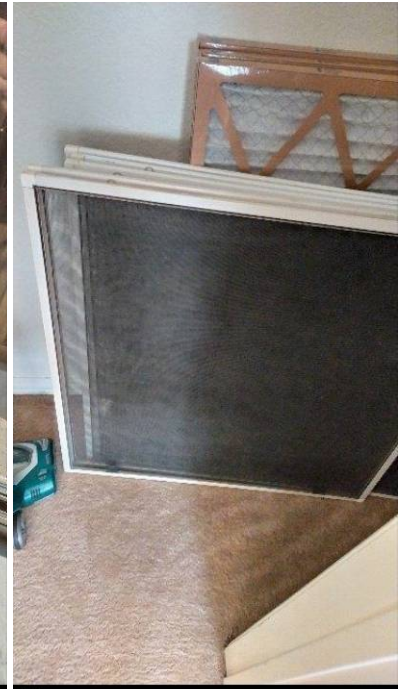
Screens

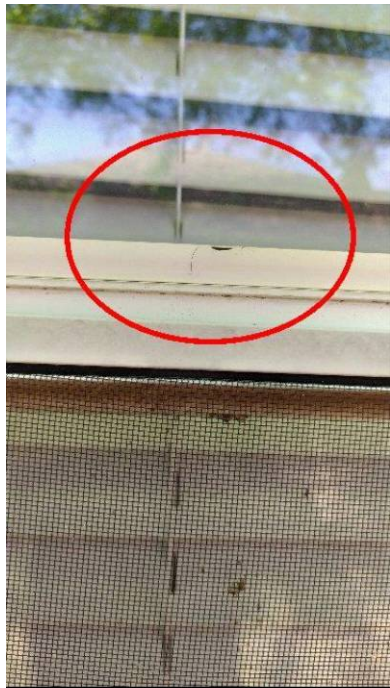
Damaged bead

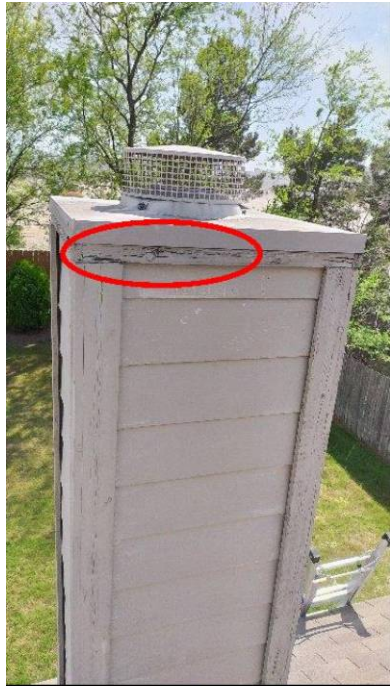
Wood deterioration damage was noted at the chimney siding and/or trim; we recommend repair and/or replacement to help prevent further damage.

Chimney trim rot

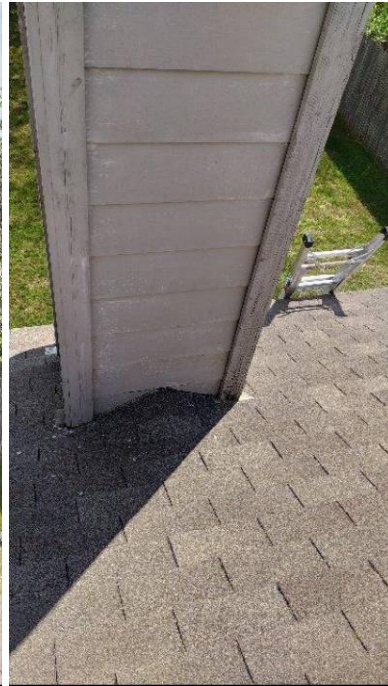
Peeling paint was observed on the chimney surface; we suggest scraping, priming and painting to protect the chimney from premature weathering.

Needs paint

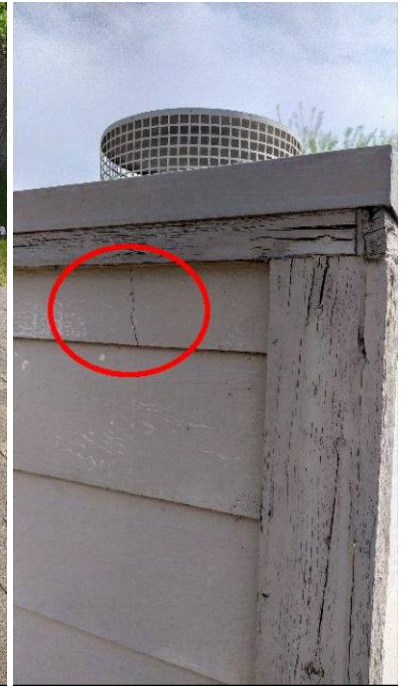
Trim rot/small crack

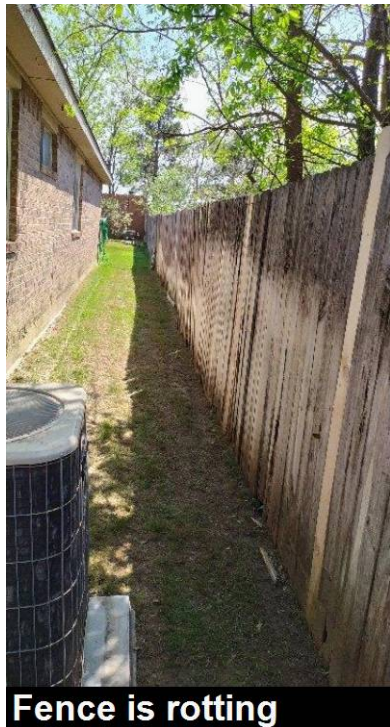
Fence is rotting

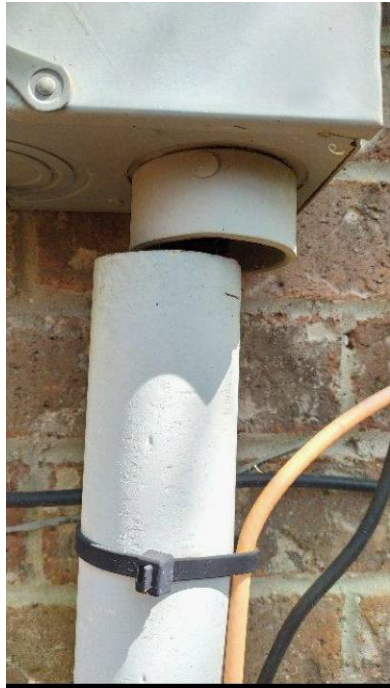
Damaged conduit

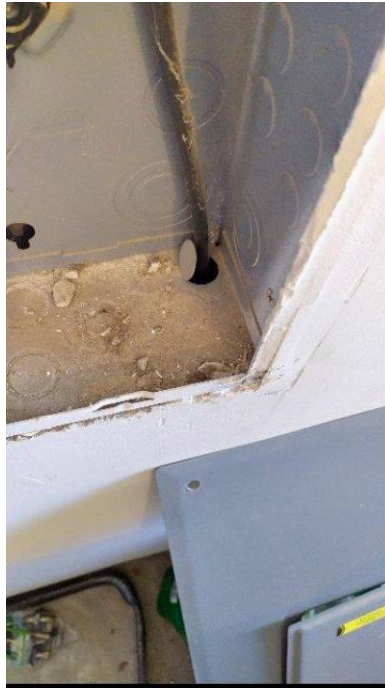
Need cable clamp

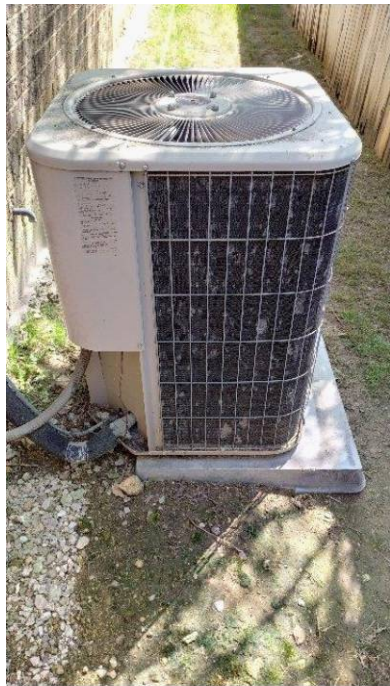
Damaged fins

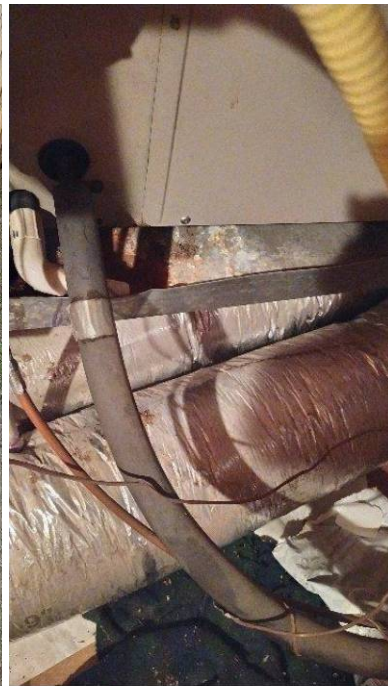
Rust in pan

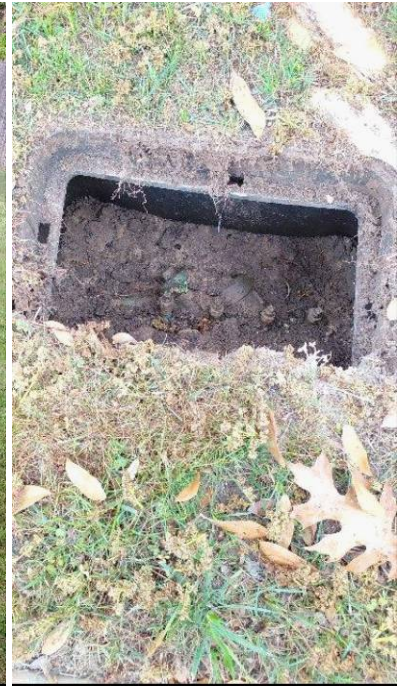
Backflow buried
