INSPECTION REPORT

**5505 SHADY DRIVE
FORT WORTH, TX 76135**

Concerning: _____
5505 Shady Dr, Fort Worth, TX 76135
(Address or Other Identification of Inspected Property)

By: Michael Coviello #20659 _____ 3/26/2020
(Name and License Number of Inspector:) (Date)

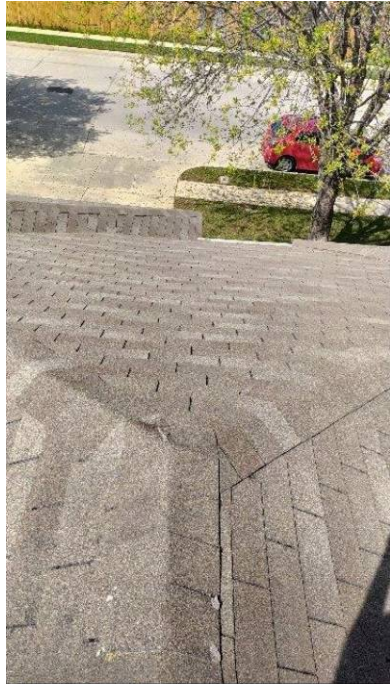
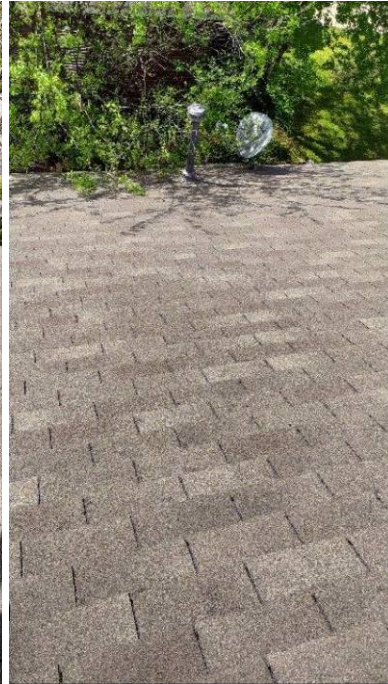
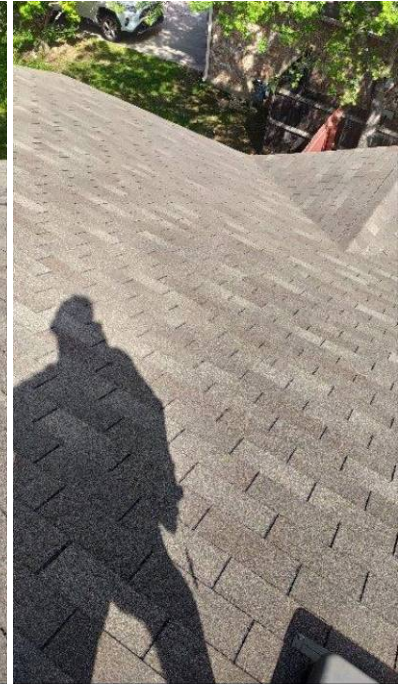
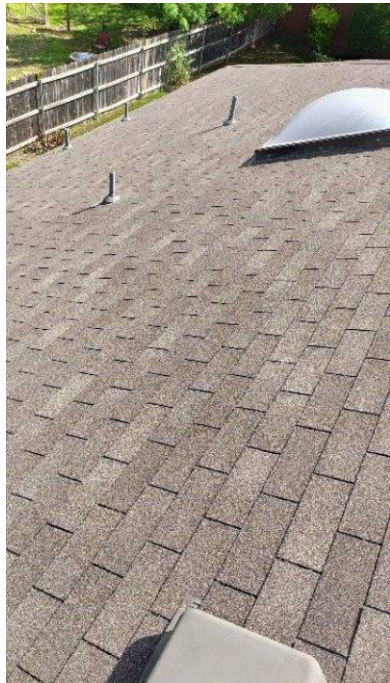
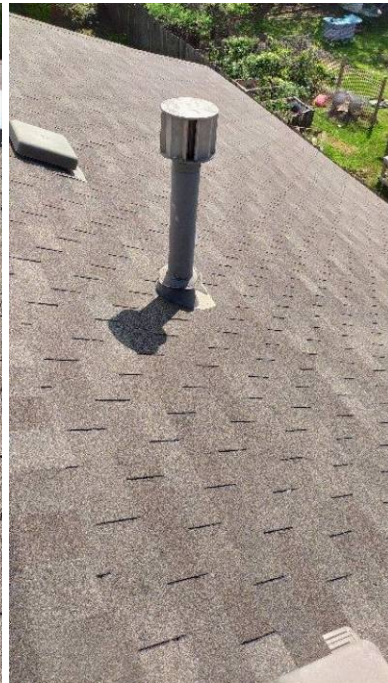
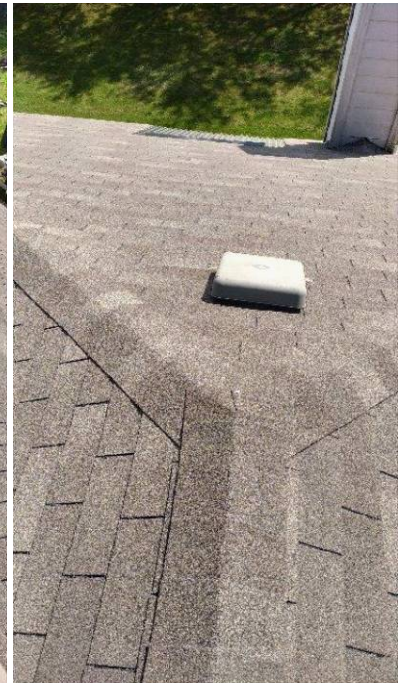
Roof view

Three-tab or fiberglass type shingles. Note: The average life expectancy under normal installation/conditions is about 15-20 years.

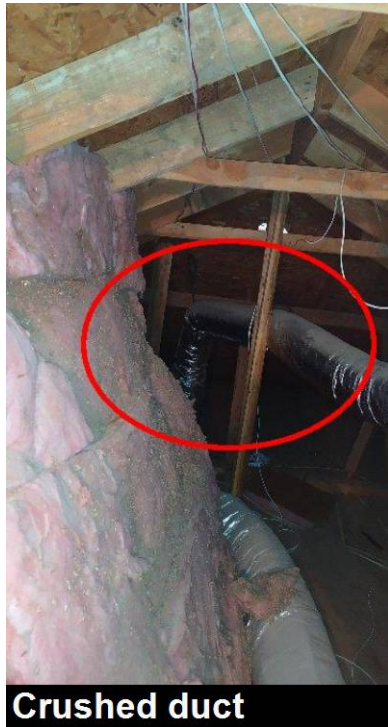
One or more area(s) of duct works were crushed or air flow appeared to be restricted; we recommend repairs or rerouting of the duct as required to help ensure satisfactory operation.

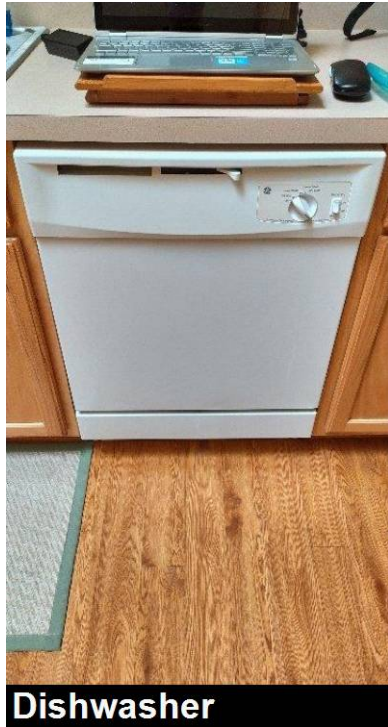
Rust was observed on the racks of the dishwasher.

There was no drip loop installed on the dishwasher drain line. A drip loop is when the dishwasher drain hose is looped up and (preferably) securely fastened to the underside of the counter. It is installed to help prevent backflow of wastewater from the sink into the dishwasher. We recommend evaluation and/or repair by a qualified plumber or handyman.

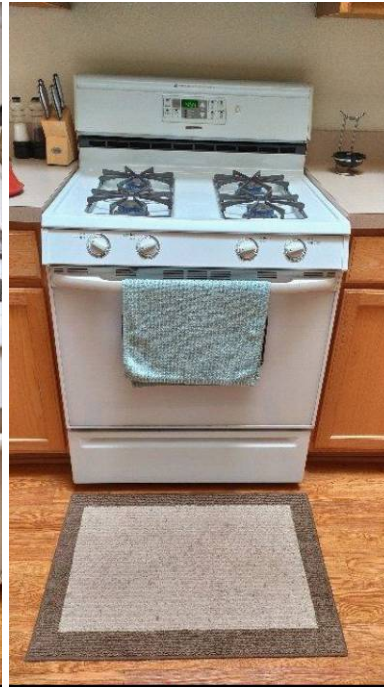
Burners lit
